Gold, W.J., G.J. Blaszak, M. Mettemeyer, A. Nanni, and M.D. Wuerthele,  
"Strengthening Dapped Ends of Precast Double Tees with Externally  
Bonded FRP Reinforcement," ASCE Structures Congress 2000,  
Philadelphia, PA, M. Elgaaly, Ed., May 8-10, CD version, #40492-045-003,  
9 pp.

# **Strengthening Dapped Ends of Precast Double Tees with Externally Bonded FRP Reinforcement**

William J. Gold, Gregg J. Blaszak, Matt Mettemeyer, Antonio Nanni,  
and Michael D. Wuerthele

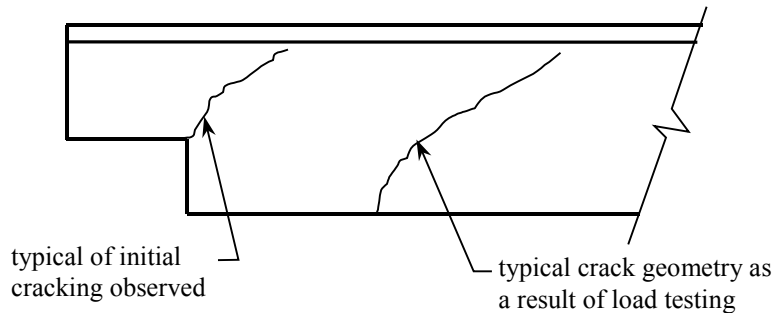
**Figure 2: Crack Patterns Observed**

The garage was originally designed to receive asphalt overlays on Level 2 (250-mm overlay) and Level 3 (400-mm overlay). However, almost 5 years after the garage's original construction, these overlays had yet to be placed. Arising concerns for the structural adequacy of the precast double tee beams further delayed placement of the overlays. Cracking at the re-entrant corners of the dapped ends of the double tees was observed and initially gave cause for concern. Cracking was observed in nearly every double tee in the garage, and though the crack angle varied widely, most cracks were inclined between  $0^\circ$  (horizontal) and  $45^\circ$ .

Due, in part, to concerns arising from these cracks, an independent engineering firm was retained to perform a comprehensive condition survey of the garage. As part this condition survey, four of the double tee beams were selected to be load tested in order to assess the structural adequacy of these beams. During load testing, flexural-shear cracking developed at a location approximately 1.5-m from the dapped ends. As loading increased, the flexural-shear cracking became so severe that the beams were deemed to have failed at roughly 75% of their design capacity.

At the recommendation of the engineering firm conducting the condition survey, the double tees required supplemental strengthening. The strengthening work had to be

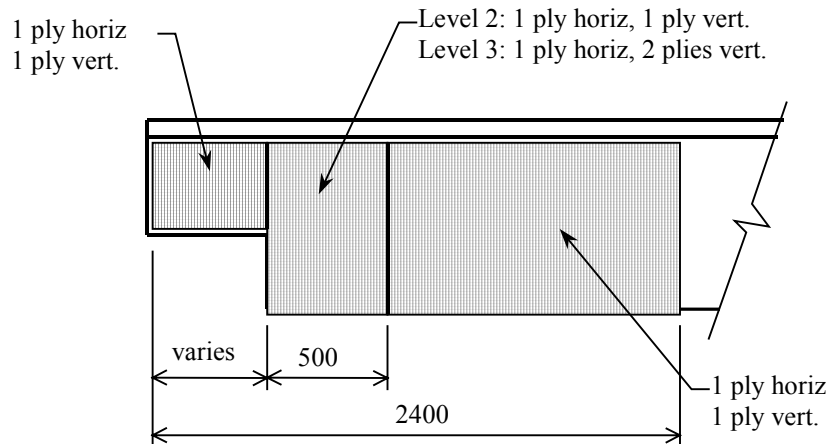
**Figure 3: Layout of the FRP Reinforcement**

The overall gravity loads that the double tees were designed to resist are shown in Table 1. The total demand on the Level 3 double tees is greater due to a thicker asphalt overlay and exposure to snow loading. Based on the independent condition survey, the deficiencies in the double tees that needed to be addressed were both flexural and shear deficiencies at the ends of each tee.

In order to accommodate any horizontal component of force and to provide additional anchorage for the vertical FRP reinforcement, horizontal plies of FRP reinforcement were added to the sides of the beams as well. The final layout of the reinforcement is shown in Figure 3.

In addition to the FRP shear reinforcement, two 100-mm wide strips of MBrace CF 130 were placed longitudinally on the soffit of the double tee stems. This reinforcement was used to limit the flexural strain level on the stem soffit to 0.005 mm/mm under a positive bending moment of 493-kN·m.

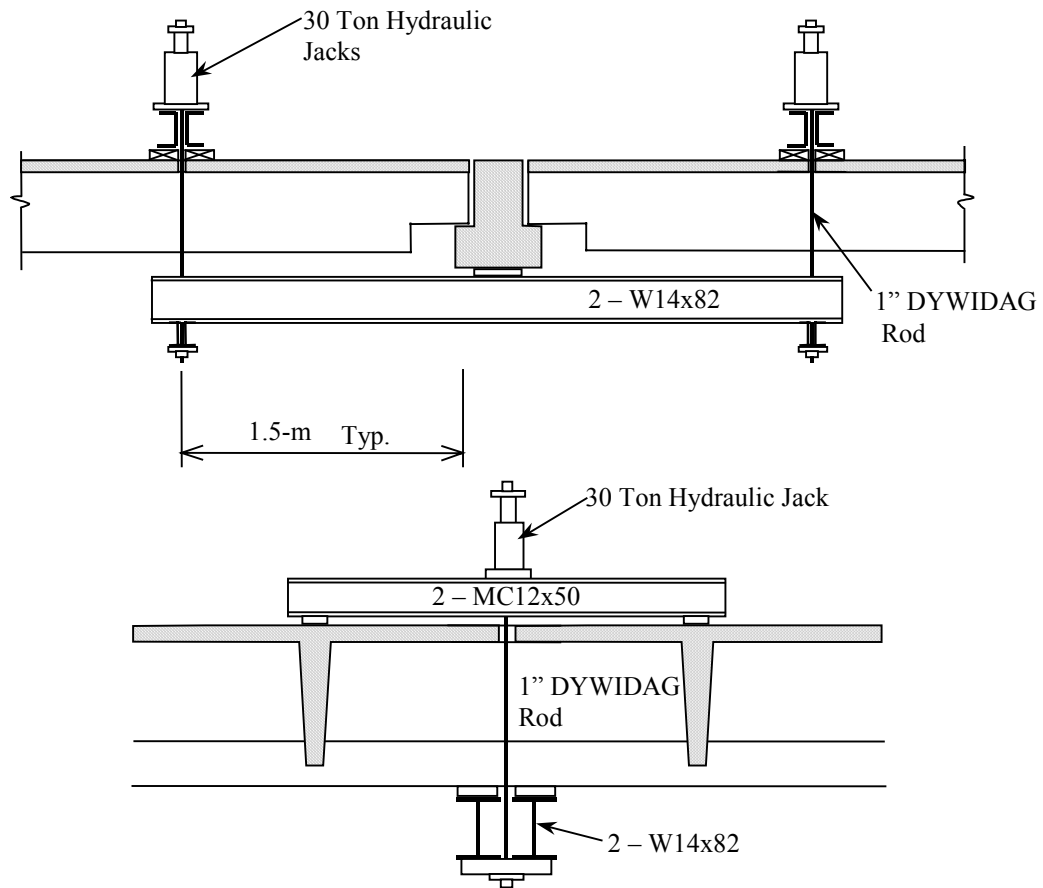
**Figure 4: Load Testing Setup**

In order to prove the FRP system, the test loads used had to generate at least 85% of the total design factored shear force at the support. During testing, deflections and strain levels in the beam were monitored to insure that the beam was performing in the elastic range. Table 4 summarizes the actual shear levels that were induced in the beams during the load test.

A pilot test was conducted to prove the design of the FRP reinforcement. The pilot test was conducted on the same two double tees that were previously failed by load testing during the condition survey (one on Level 2 and one on Level 3). The failed tees were repaired by epoxy injecting the cracks that had formed and installing the FRP reinforcing system. These tees were then load tested using hydraulic jacks to apply the load. The load testing setup is shown in Figure 4.
